BEAVER LAKE LODGE DAM

NDI I.D. NO. PA-00300
PENNDER I.D. NO. 52-93

PHASE I INSPECTION REPORT
NATIONAL DAM INSPECTION PROGRAM

JUNE 1981

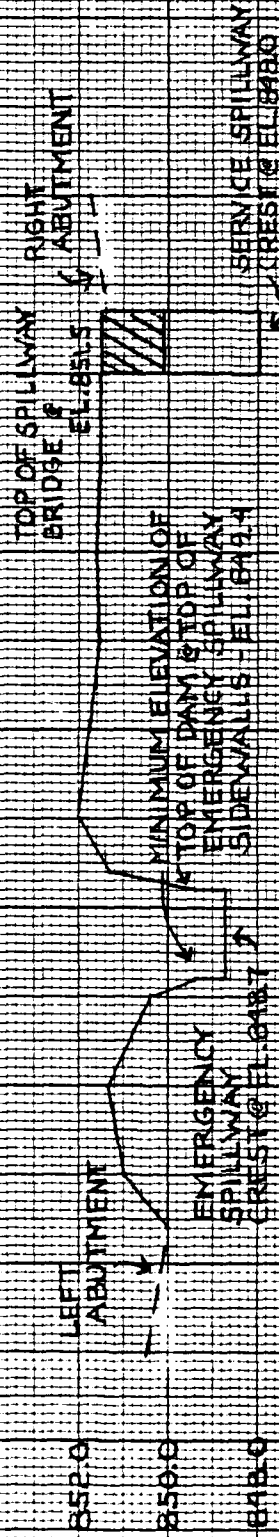
PROFILE OF DAM CREST
FROM FIELD SURVEY

- ° Portions of the embankment are approximately 1.5 feet below the elevation of the top of the service spillway bridge.
- ° A portion of downstream embankment toe near the service spillway is unprotected and subject to further erosion.
- ° The roots of trees growing along the upstream and downstream embankment slopes may increase the seepage potential through the embankment. Furthermore, uprooting of the trees by high winds could cause substantial volumes of the embankment material to be displaced. Hence, the trees and their root system should be removed.
